# Home Report

# Scottish Single Survey

# Single Survey

| <b>Property address</b> | 12f Bayview Road<br>Invergowrie<br>Dundee<br>DD2 5AR |

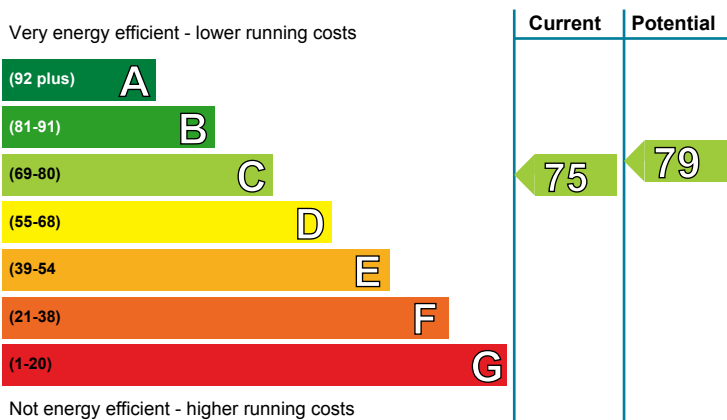
## Energy Efficiency Rating

This graph shows the current efficiency of your home, taking into account both energy efficiency and fuel costs. The higher this rating, the lower your fuel bills are likely to be.

Your current rating is **band C (75)**. The average rating for EPCs in Scotland is **band D (61)**.

The potential rating shows the effect of undertaking all of the improvement measures listed within your recommendations report.
