YOUR ONESURVEY HOME REPORT

27 Whitefauld Road
Dundee
DD2 1RJ

SINGLE SURVEY

ENERGY REPORT

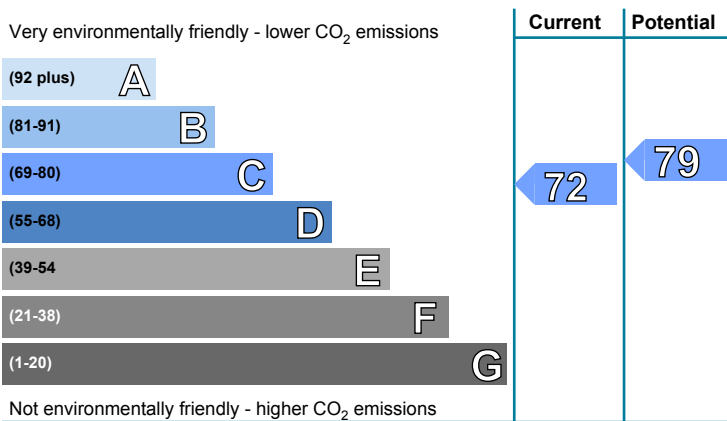
Environmental Impact (CO₂) Rating

This graph shows the effect of your home on the environment in terms of carbon dioxide (CO₂) emissions. The higher the rating, the less impact it has on the environment.
