YOUR ONESURVEY  
**HOME REPORT**

68 City Road  
Brechin  
DD9 6DL

# SINGLE SURVEY

A report on the condition of the property, with categories being rated from 1 to 3.

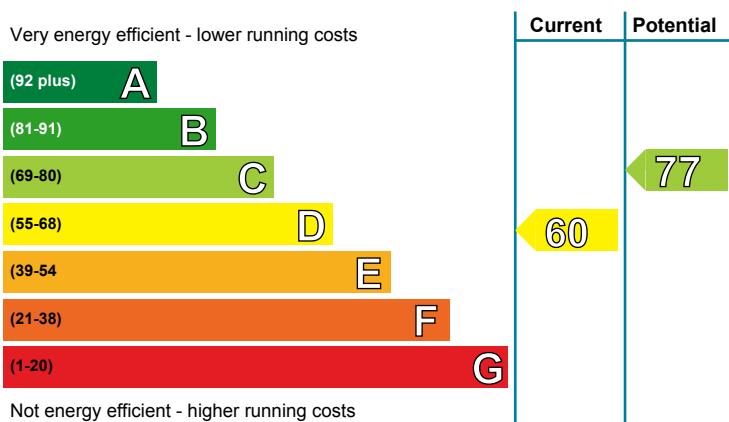
## Energy Efficiency Rating

This graph shows the current efficiency of your home, taking into account both energy efficiency and fuel costs. The higher this rating, the lower your fuel bills are likely to be.

Your current rating is **band D (60)**. The average rating for EPCs in Scotland is **band D (61)**.

The potential rating shows the effect of undertaking all of the improvement measures listed within your recommendations report.

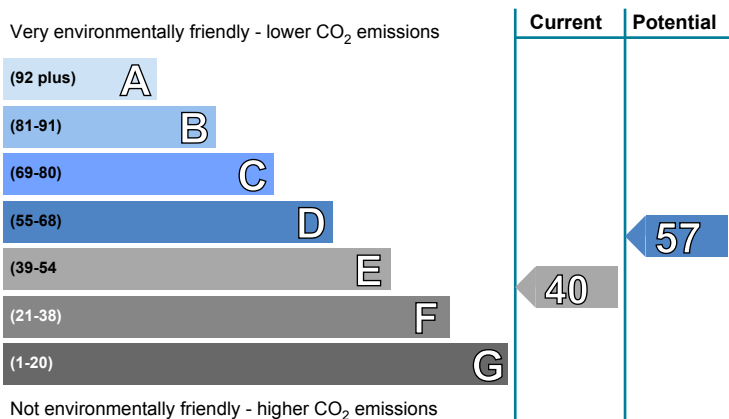
## Environmental Impact (CO<sub>2</sub>) Rating

This graph shows the effect of your home on the environment in terms of carbon dioxide (CO<sub>2</sub>) emissions. The higher the rating, the less impact it has on the environment.
