# YOUR ONESURVEY HOME REPORT

289F Strathmore Avenue

Dundee

# SINGLE SURVEY

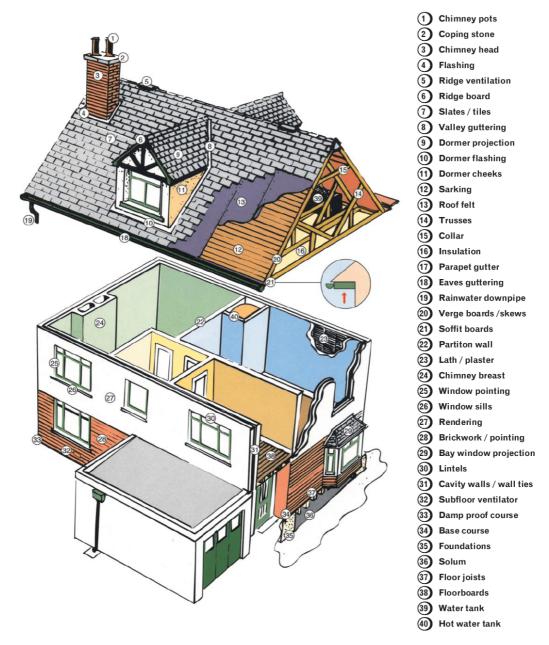
#### Sectional Diagram showing elements of a typical house

Reference may be made in this report to some or all of the above component parts of the property. This diagram may assist you in locating and understanding these items.
