YOUR ONESURVEY HOME REPORT

26a Weavers Loan
Dundee
DD3 6NT

SINGLE SURVEY

Surveyor Reference	EA2990
Customer	Mr. Brian Torrance
Selling address	26a Weavers Loan
	Dundee
	DD3 6NT
Date of Inspection	18/02/2025
Prepared by	Graeme Millar, MRICS
	Dundee - Allied Surveyors Scotland Ltd

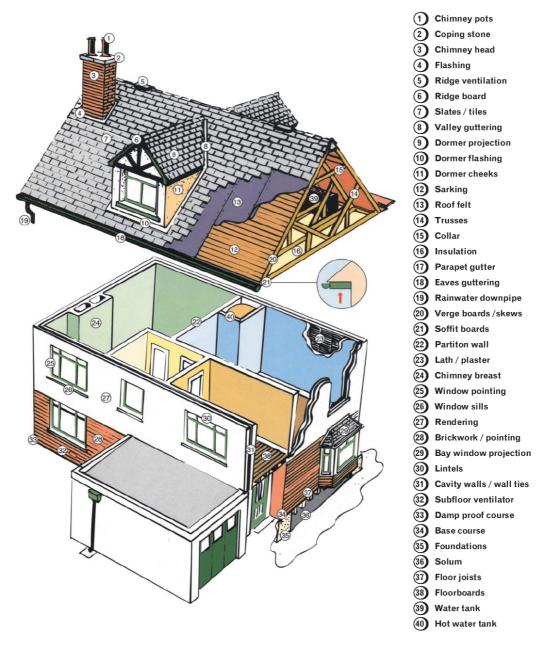
Sectional Diagram showing elements of a typical house

Reference may be made in this report to some or all of the above component parts of the property. This diagram may assist you in locating and understanding these items.
