YOUR ONESURVEY HOME REPORT

483 Charleston Drive
Dundee
DD2 4HS

SINGLE SURVEY

Surveyor Reference	EA3022
Customer	Mr. Scott Spiers
Selling address	483 Charleston Drive
	Dundee
	DD2 4HS
Date of Inspection	19/02/2025
Prepared by	Blair Ferguson, MRICS
	Dundee - Allied Surveyors Scotland Ltd

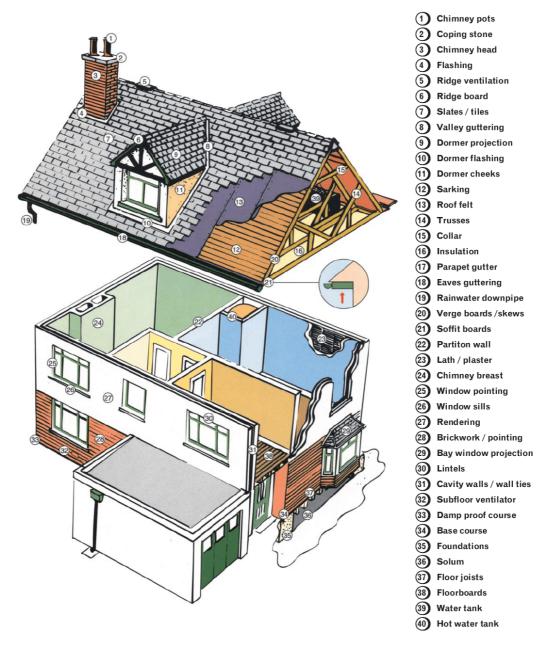
Sectional Diagram showing elements of a typical house

Reference may be made in this report to some or all of the above component parts of the property. This diagram may assist you in locating and understanding these items.
